# **WATER FRAMEWORK DIRECTIVE ASSESSMENT**

## **Point of Ayr Cable Route Foreshore Works**

Document Reference Number PF.3.4

Applicant: Liverpool Bay CCS Limited

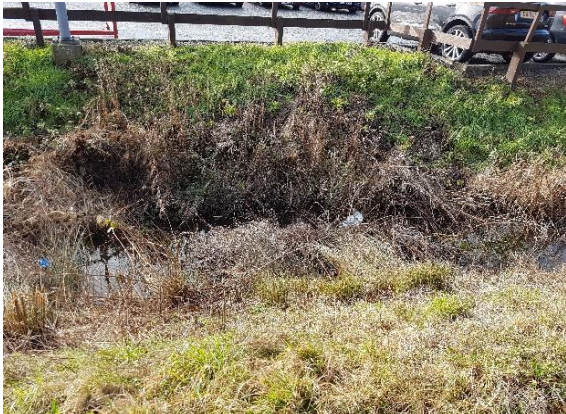
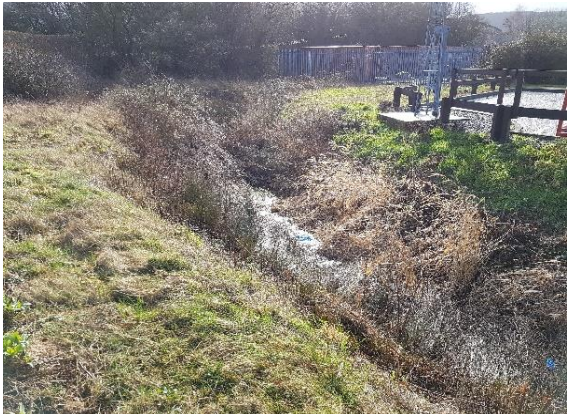
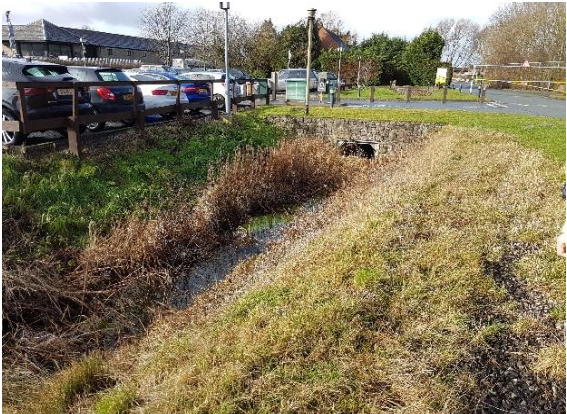
| Site Reference | PoA Ditch 2 | SJ 11919 83934 |
|---|---|---|
| View looking across the channel | View looking upstream | View looking downstream from the right bank. Flow direction estimated from OS mapping |
| <p>This watercourse is a trapezoidal ditch with a straight planform, over-deepened with resection channel and banks. The channel has a low gradient and no perceptible flow. Water quality was poor, and the channel bed was not visible. The channel dimensions are approximately 1m wetted width and approximately 0.5m deep water at the time of survey; bankfull is approximately 5m wide with a bankfull water depth estimated at 2.5m, although the bed was not visible, and it was not safe to estimate the depth. The bank face has a simple vegetation structure on both banks and is managed. The left bank land use is a car park, the right bank top land use is a road with low volume traffic for access to the business park and industrial areas.</p> | | |

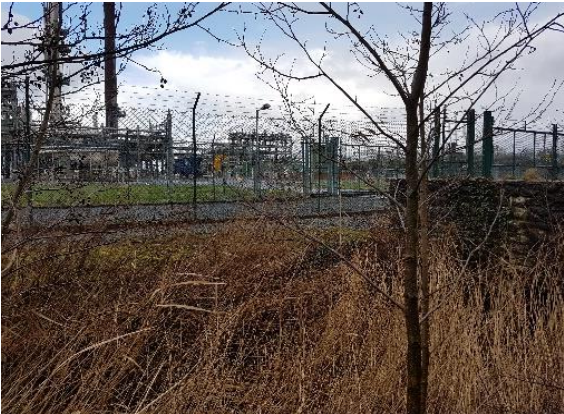
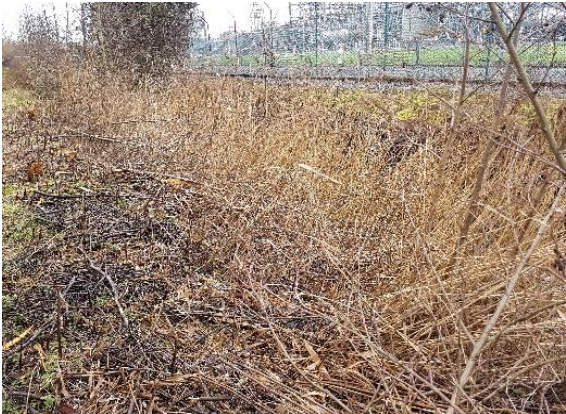
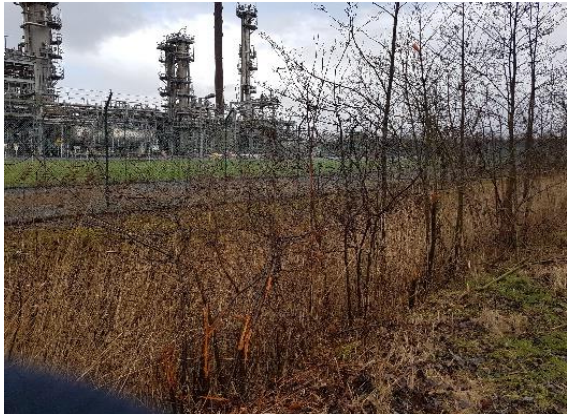
| Site Reference | PoA Ditch 2 | SJ 12316 83749 |
|---|---|---|
| View of channel – flow direction is unknown | View of channel – flow direction is unknown | View of channel – flow direction is unknown |
| <p>This watercourse is a trapezoidal ditch with a straight planform, over-deepened with resectioned channel and banks. The channel has a low gradient and no perceptible flow. Flow direction could not be determined on the day of survey. The channel bed was not visible. Vegetation is dominated by tall herbs with some scrub vegetation. The drain flows around the perimeter of the gas terminal with wasteland dominating the 50 m land use on the other bank top.</p> | | |

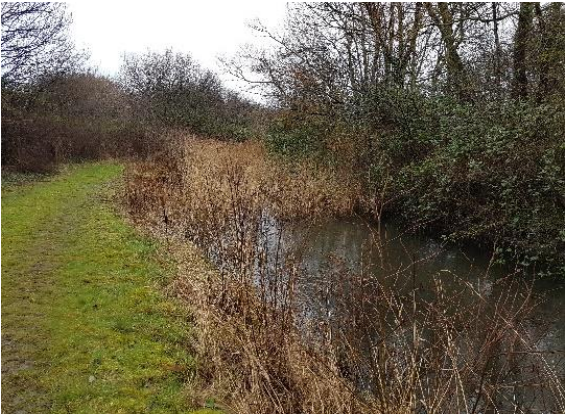
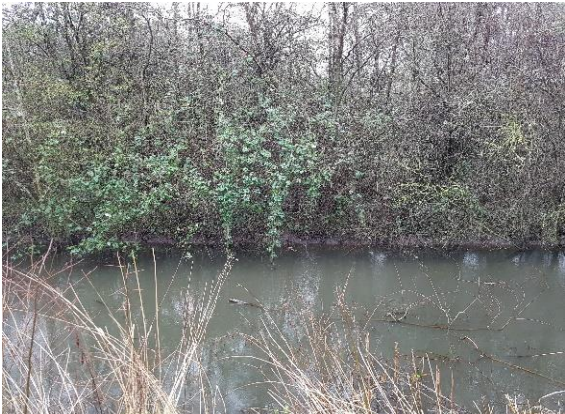
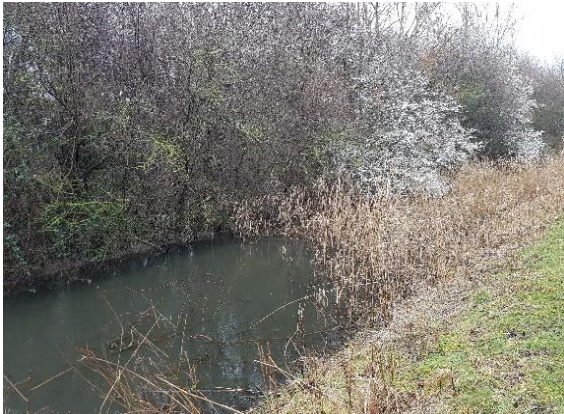
| Site Reference | Talacre Brook | SJ 12021 84232 |

| Site Reference | Talacre Brook | SJ 12021 84232 |
|---|---|---|
| <p>Looking upstream at the upstream extent of the survey reach. The pond feature is a short distance upstream</p> | <p>View across the channel taken from the right bank looking to the left bank</p> | <p>View looking downstream taken on the right bank</p> |

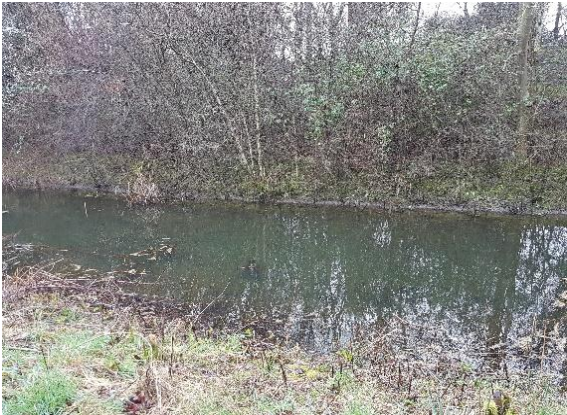
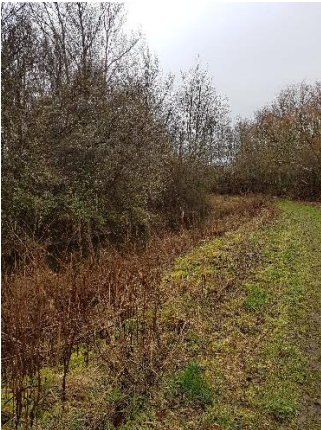
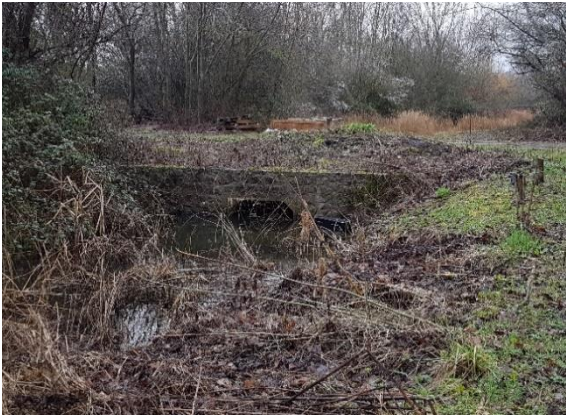
| Site Reference | Talacre Brook | SJ 12021 84232 |
|---|---|---|
| View across the channel looking upstream | View looking downstream showing managed bank top used for recreational purposes (dog walking) | View of downstream culvert which impounds the water. |
| <p>This watercourse is a modified channel with a straight planform, over-deepened with resection channel and banks. The channel has a low gradient and no perceptible flow. Water quality was poor, and the channel bed was not visible. The channel dimensions are approximately 4m wetted width and approximately 1m deep water; bankfull is approximately 5m wide with a water depth at bank full estimated at around 2m, although the bed was not visible, and it was not safe to estimate the depth. There is a continuous line of trees on the left bank with a complex vegetation structure, and no trees along the right bank top. The right bank is mown grassland with uniform vegetation structure. The 5m land use is broadleaf woodland and grassland on the right bank. Urban/commercial development is present in the 50 m land use.</p> | | |

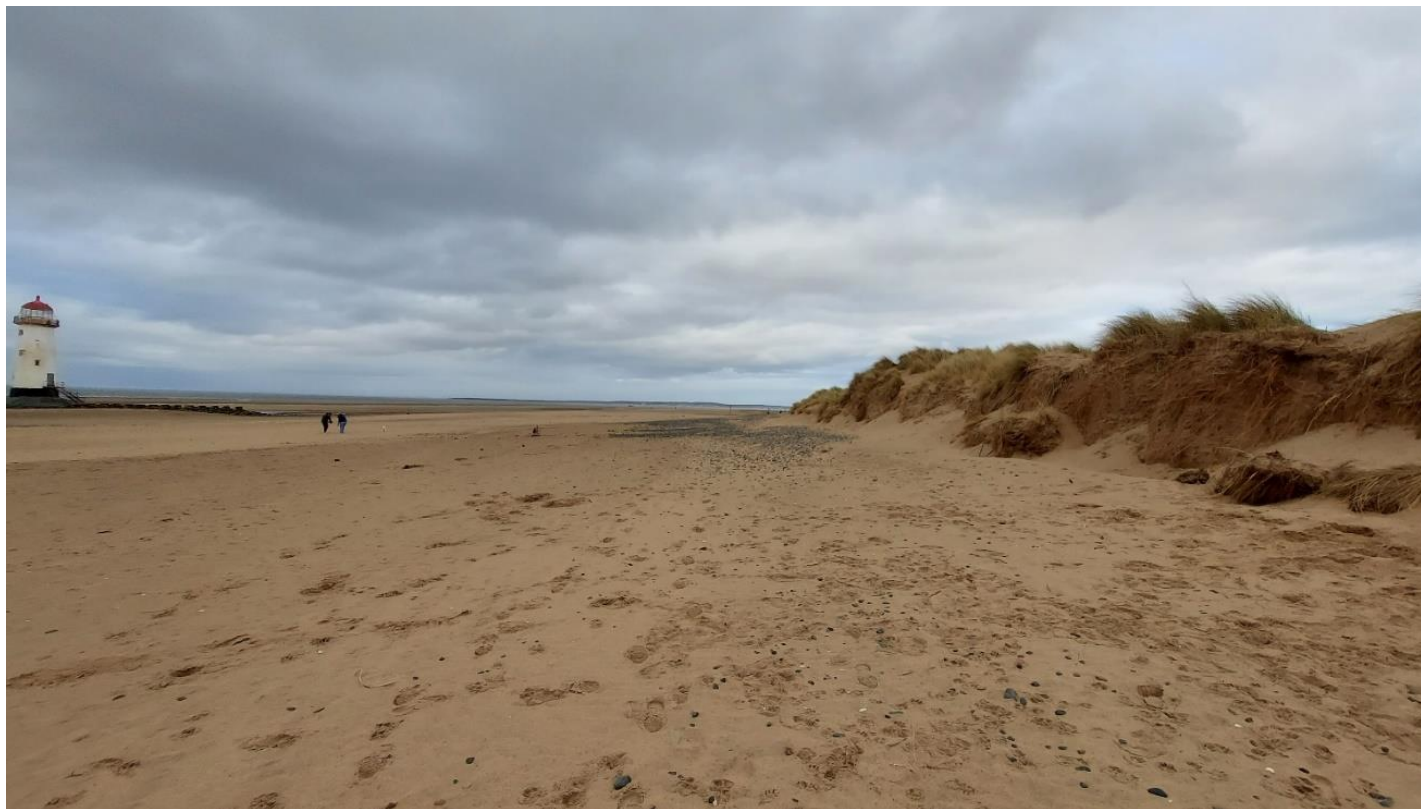
View of the beach zone at Talacre Beach
